**DAMES POINT MARINE TERMINAL
BERTHS 16 AND 17
JACKSONVILLE, FLORIDA
BOND INSPECTION REPORT**

DECEMBER 17, 2020

TRAPAC

Jacobs Engineering Group, Inc.

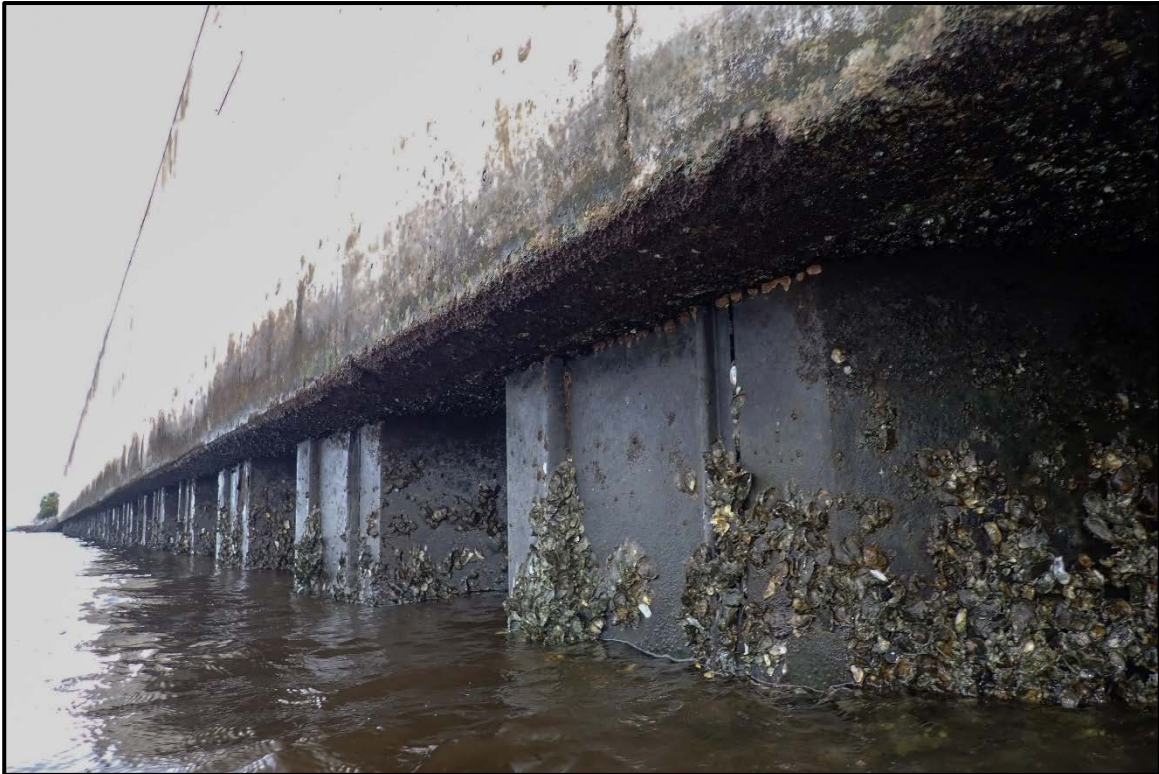
The steel combination wall (combi-wall) is in **Good** condition with a thick, rubber-like, epoxy coating covering the full exposed height of the wall (Photo 2-8). In isolated locations, the coating is torn and the underlying steel is exposed (Photo 2-9). The tears are minimal and observed on less than 5 percent of the sheet pile wall area, typically at the sheet pile interlocks and corners (Photo 2-10). Where exposed, the steel is in good condition with no corrosion observed. In addition to tears in the coating, there are areas where the coating has delaminated from the steel most notably along the top 2 ft of exposed wall below the pile cap (Photo 2-11). In total, approximately 5 percent of the sheet pile wall area is torn or delaminated.

PHOTO 2-8 Bulkhead wall with intact epoxy coating.

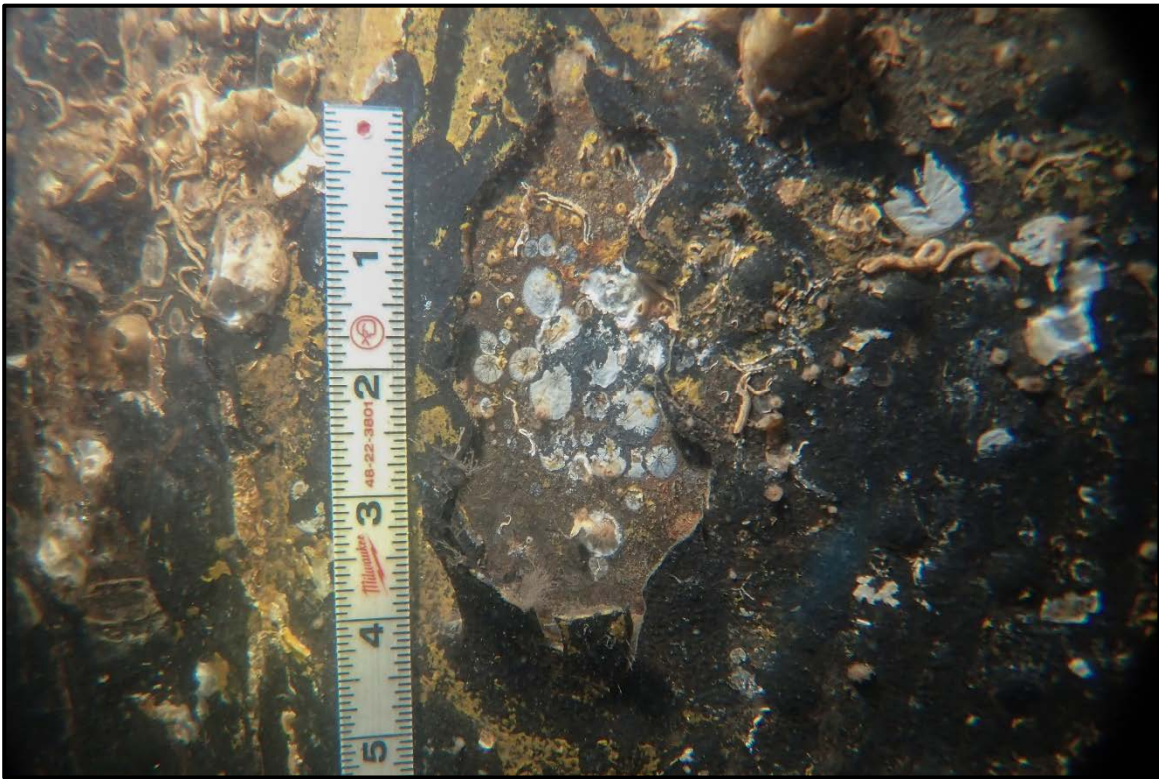
PHOTO 2-9 Isolated tear in epoxy coating on bulkhead wall.

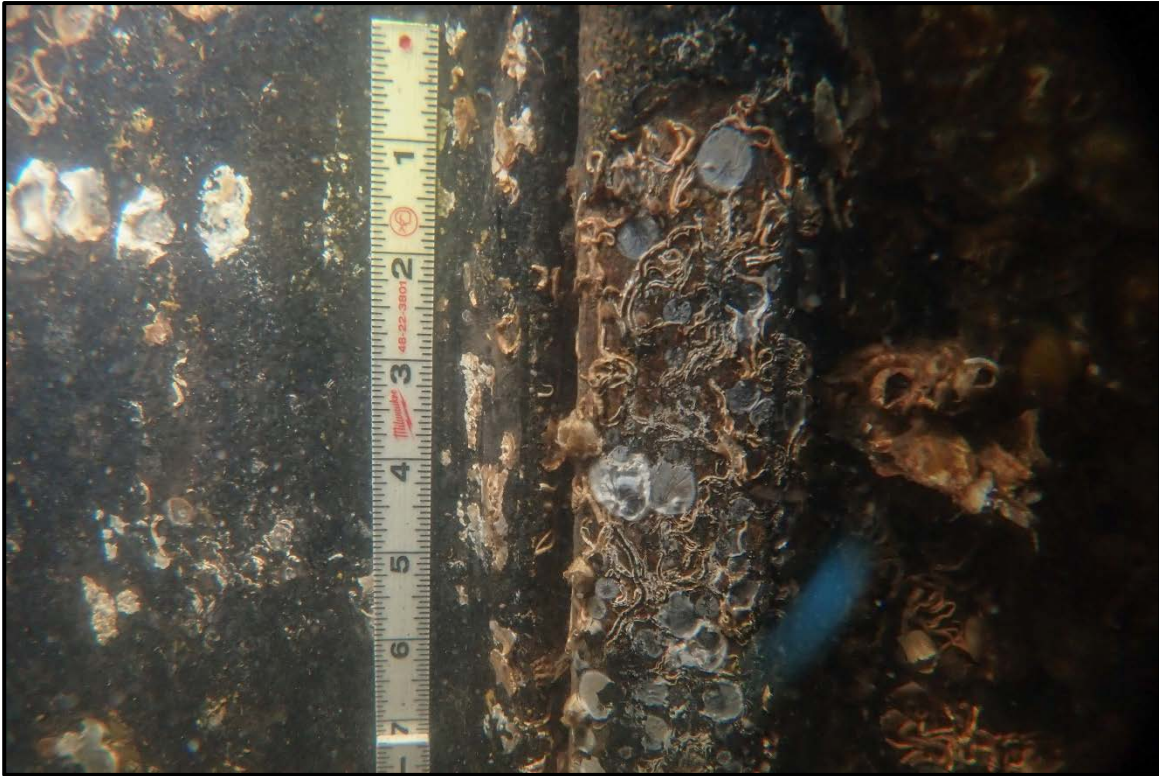
PHOTO 2-10 Tear in epoxy coating at interlock in combination wall.

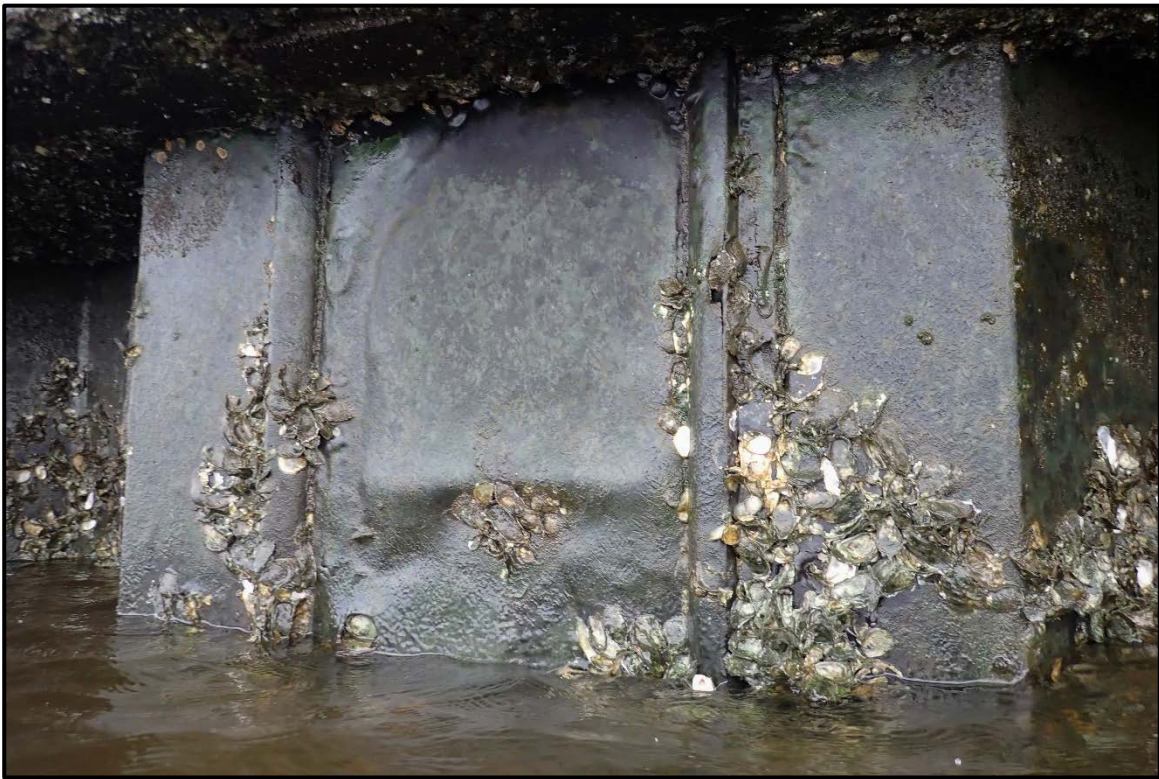
PHOTO 2-11 Delaminating epoxy coating with bubbles forming on the outer flange of the king pile.

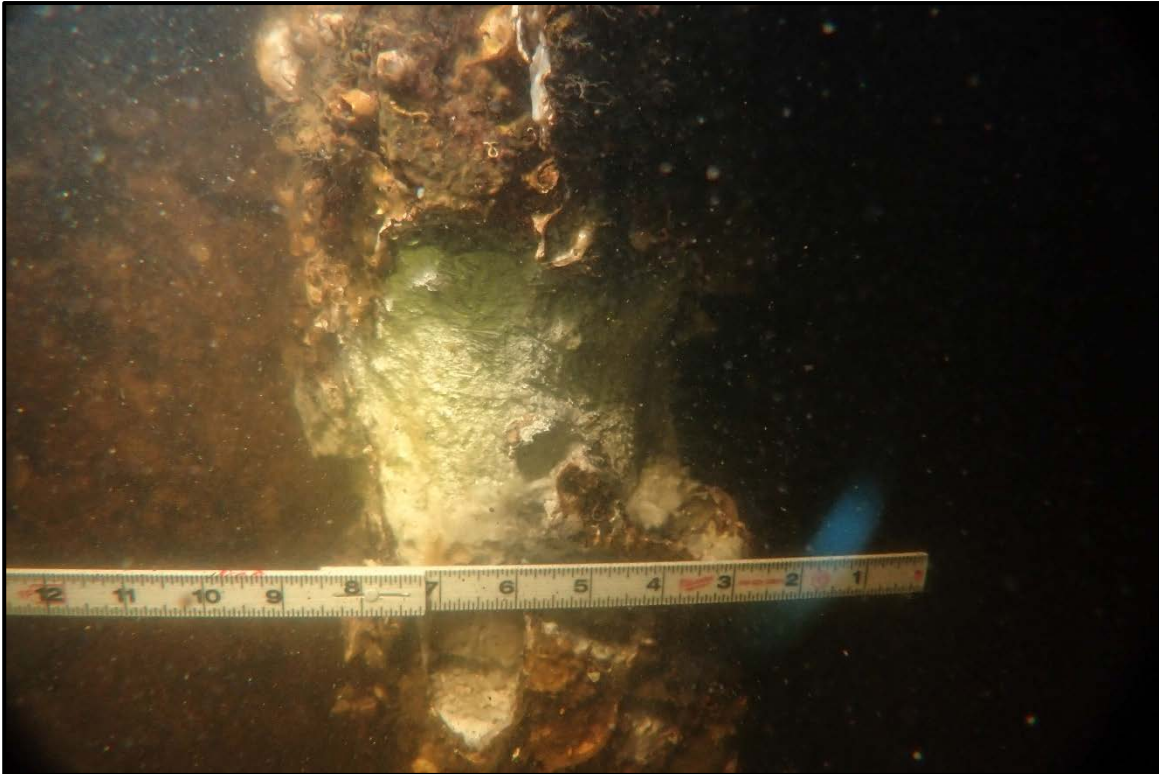
The Cathodic Protection System is in **Poor** condition. Overall, the sacrificial anodes exhibit an average section loss (depletion) of 20 to 25 percent over the length of the wall (Photo 2-12), however the level of deterioration varies between 5 and 50 percent. Additionally, significantly less anodes were observed on the wall than the as-built drawings indicate. While a detailed inspection of every anode is outside the scope of this inspection, based on the number of anodes observed by the divers, approximately two-thirds of the anodes are estimated to be missing including at least one test station anode (Photo 2-13). Among the existing anodes, one of the two anode mounting brackets are broken at eight locations along the wall (Photo 2-14). At these broken mounting brackets, the weld between the bracket and the sheet pile web is typically the failure point. Additionally, the sheet pile webs exhibit rectangular cutouts in the protective coating at multiple locations (Photo 2-15). These cutouts typically have remnants of Splash Zone epoxy and weld material, possibly indicating that anodes were previously installed at these locations, which would be consistent with the anode locations shown on the as-built drawings.

PHOTO 2-12 Aluminum alloy anode with approximately 30 percent section loss.

- Replacement of the missing anodes. Based on the as-built drawings and the inspection findings, it is estimated that approximately two-thirds of the anodes originally installed on the bulkhead wall are missing. A sacrificial anode cathodic protection system design is based on the surface area of an exposed wall in a marine environment and protects the steel wall as its coating deteriorates. It is intended to extend the life of the wall, with regular maintenance and replacement of the anodes, longer than what would be expected with coating alone. Based on the current condition of the wall and the electrical potential measurements obtained, the steel is currently protected. However, since many of the anodes are missing, the deterioration rate of the

It is recommended that the missing anodes be replaced in order to restore the full design life of the cathodic protection system and reduce the potential for corrosion damage on the bulkhead wall. Prior to a repair or replacement design, a design level inspection of the cathodic protection system should be performed to fully determine the extent and quantity of the missing anodes and identify the locations of all existing anodes. Upon completion of the design level inspection, a repair design for the cathodic protection system would be prepared.

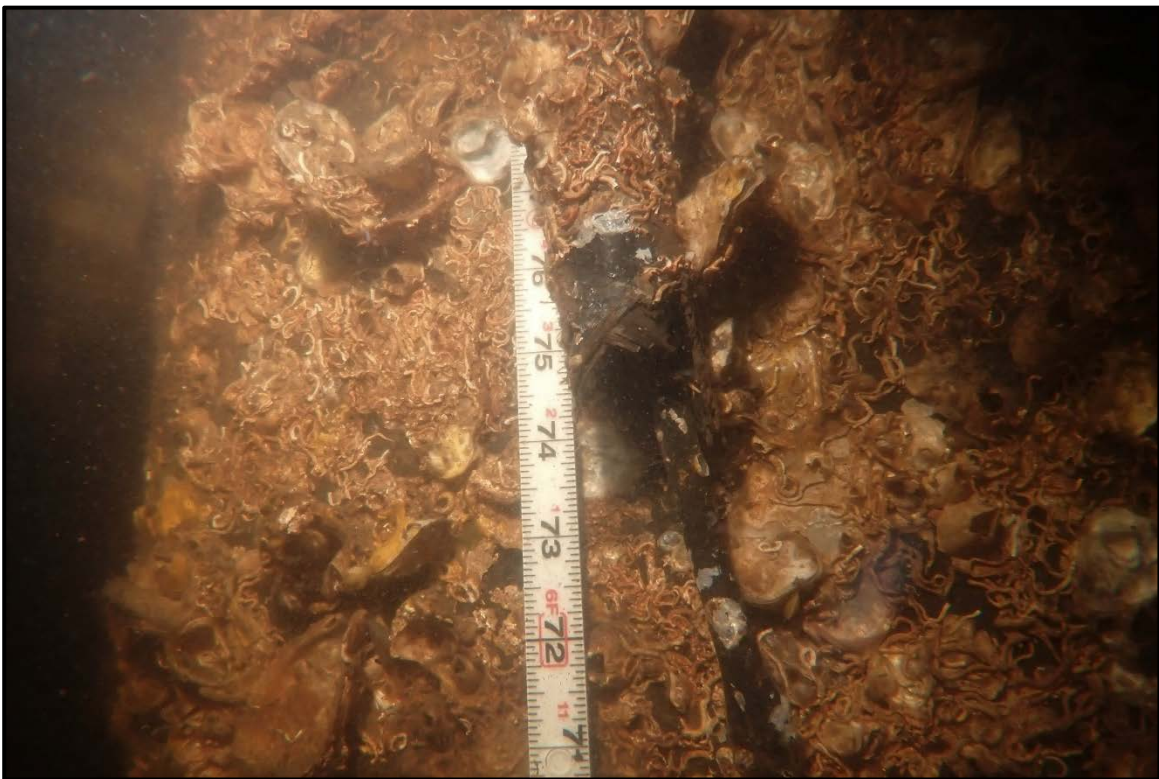
PHOTO 2-13 Broken anode test cable disconnected from test anode. Test anode missing.

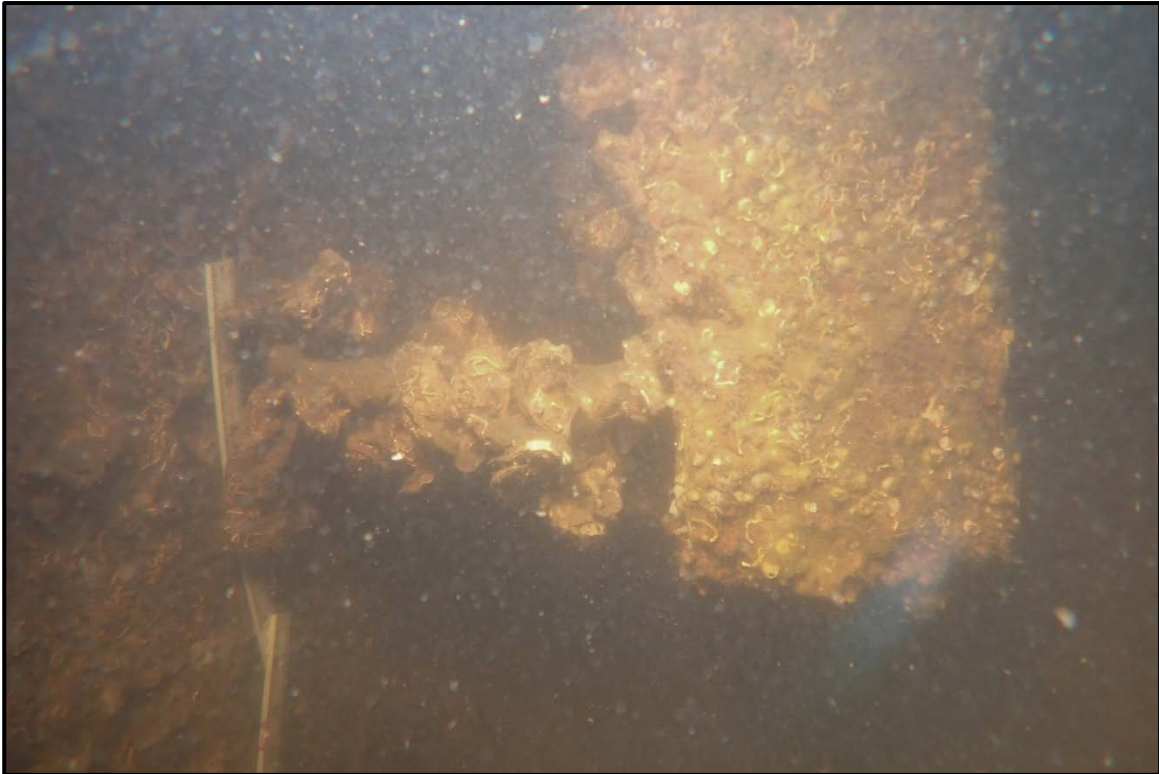
PHOTO 2-14 Aluminum alloy anode with broken lower bracket connection to sheet pile web.

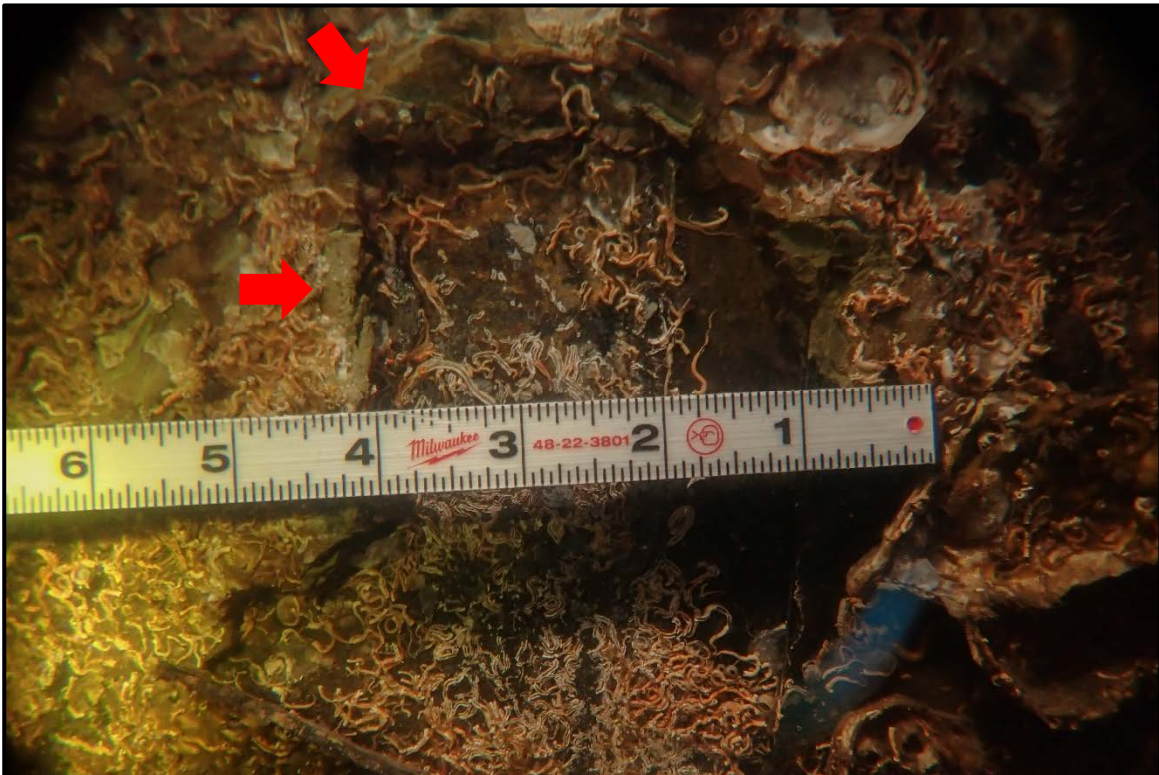
PHOTO 2-15 Sheet pile web with cutout in coating and Splash Zone epoxy where an anode bracket may have been located.

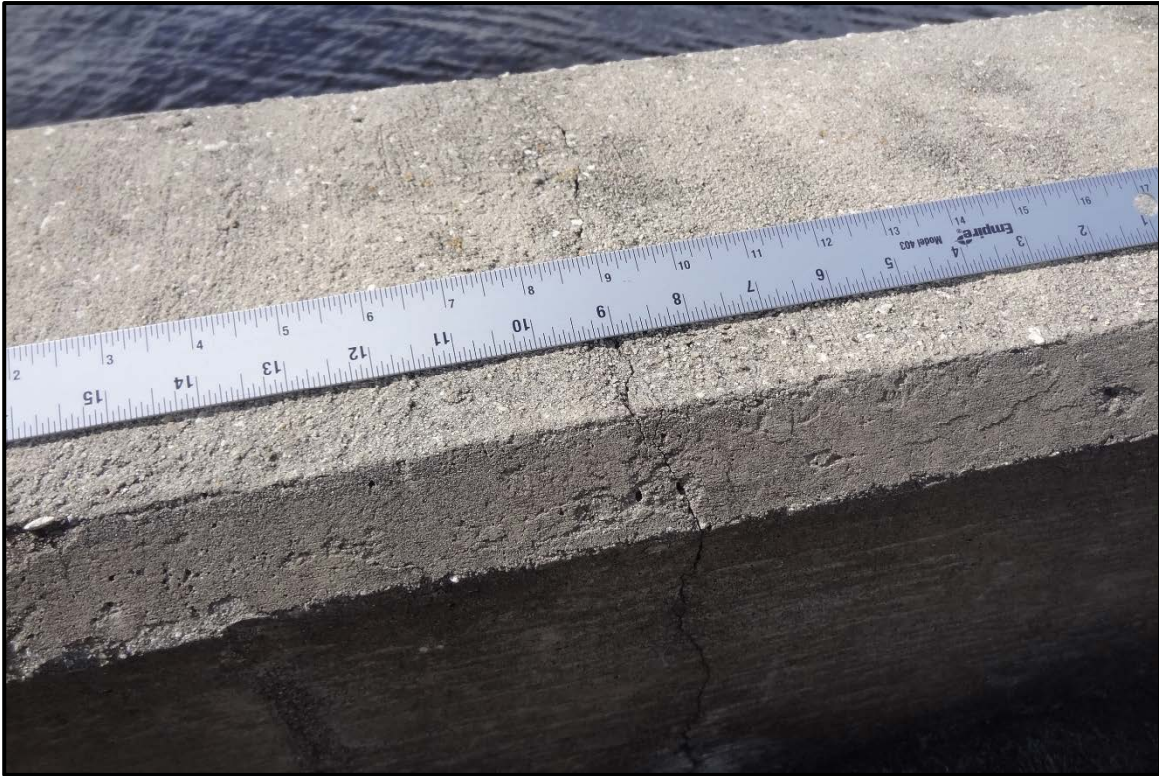
PHOTO 2-16 Typical hairline crack in concrete curb.

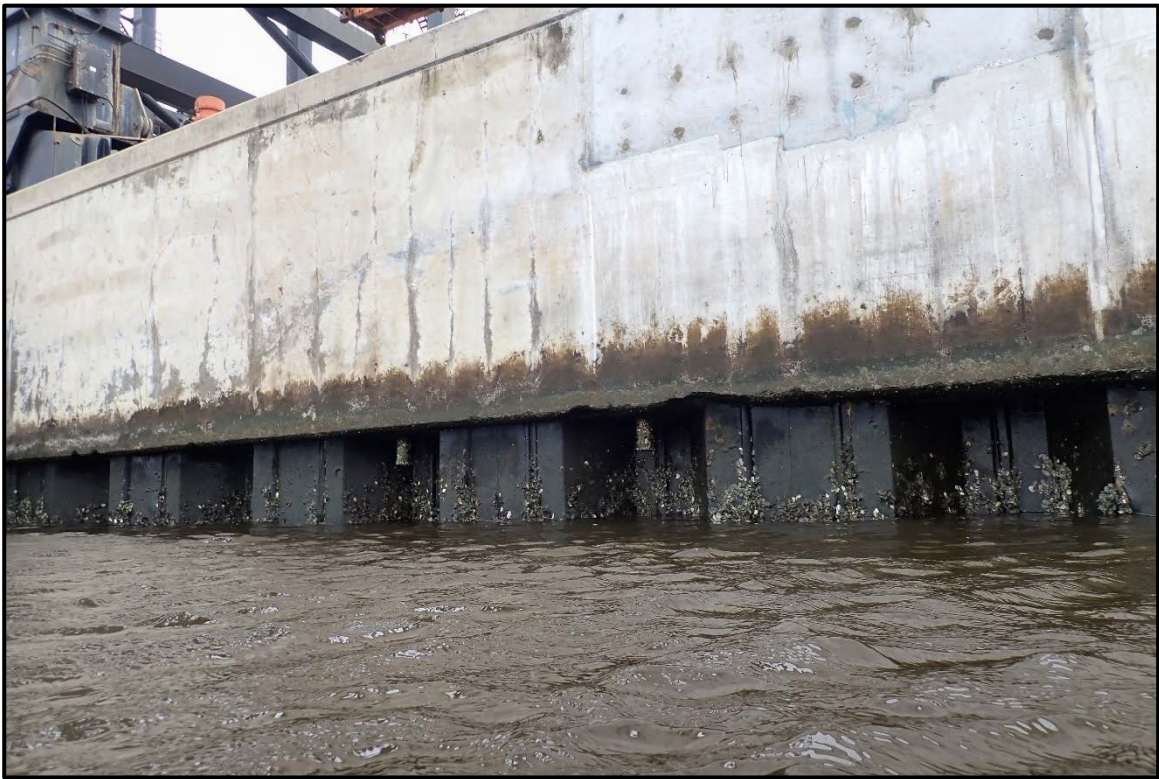
PHOTO 2-17 Capping beam with typical mechanical spalling on the bottom corner.

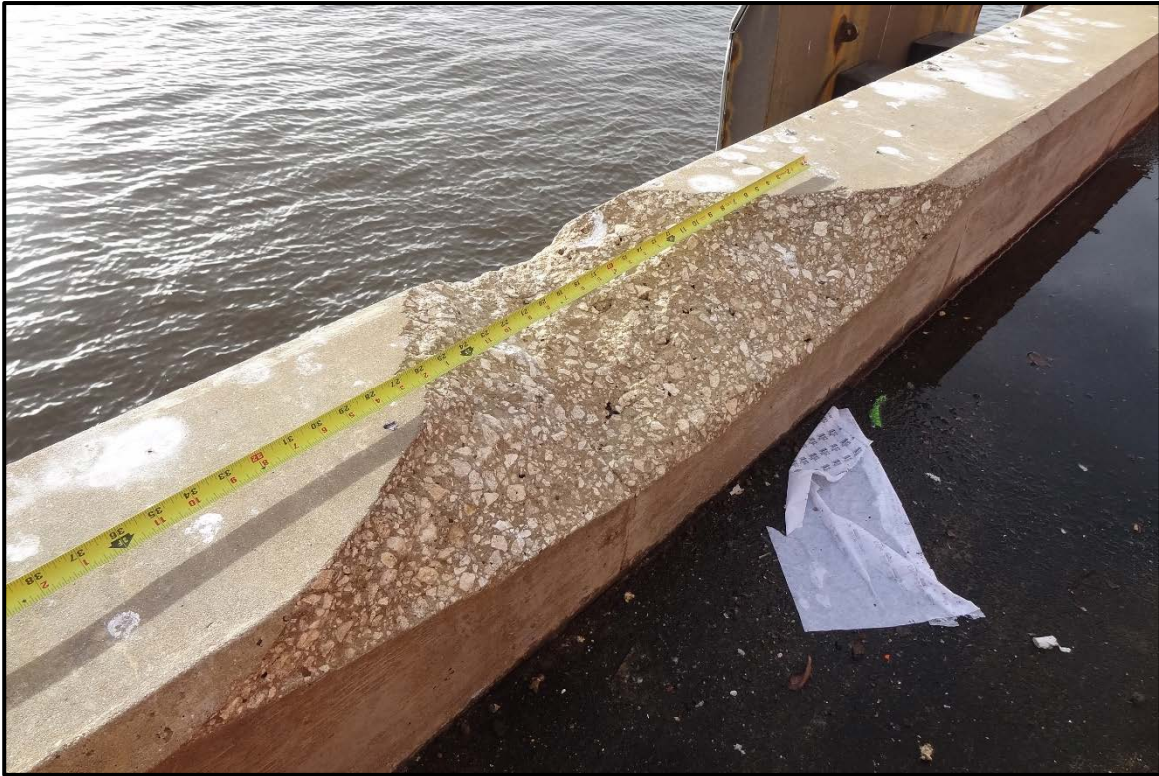
PHOTO 2-18 Mechanical spall in concrete curb at Station 25+40.

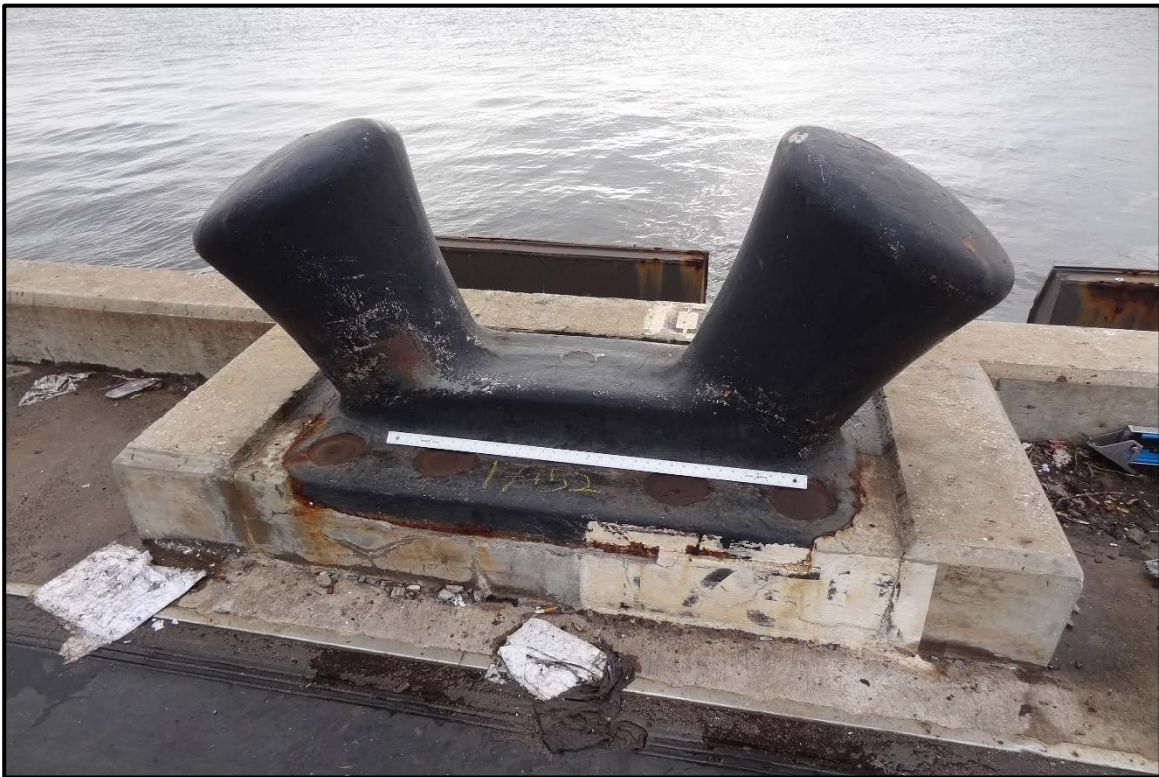
PHOTO 2-19 Typical mooring bollard with 5 percent coating loss and minor corrosion.

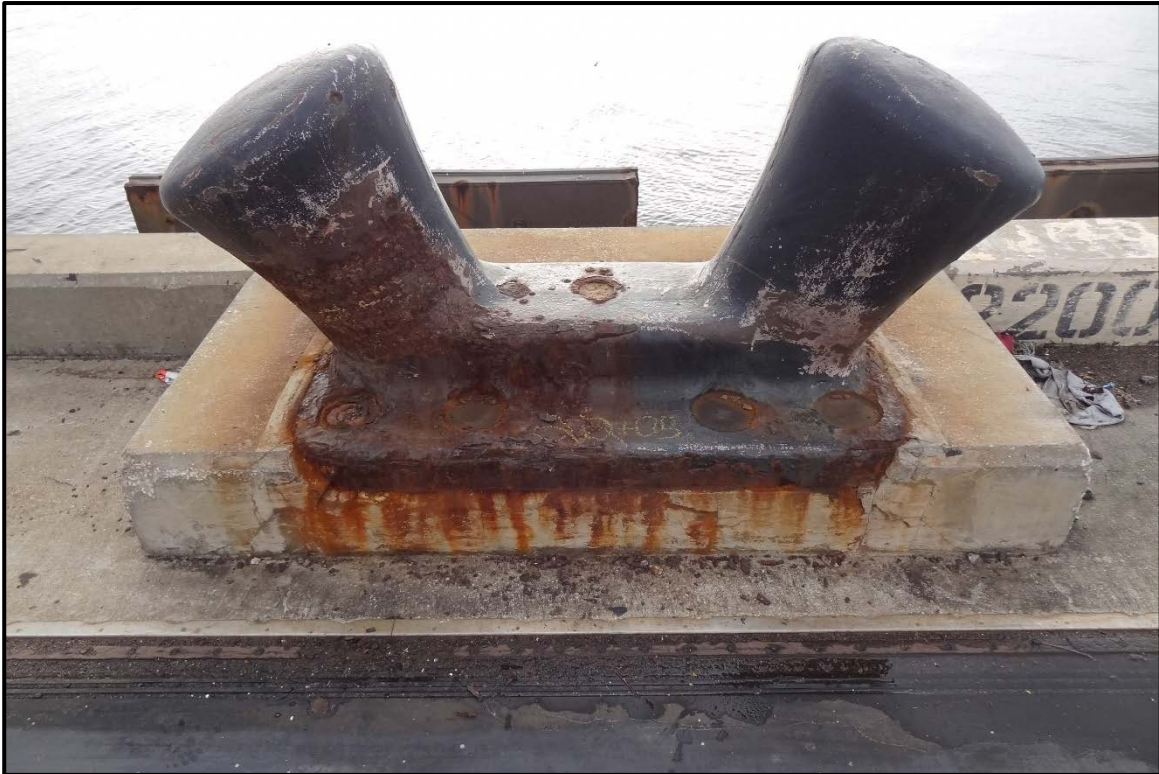
PHOTO 2-20 Mooring bollard with 25 percent coating loss and moderate corrosion and pitting.

These bollards should be cleaned and re-coated to prevent additional corrosion from occurring.

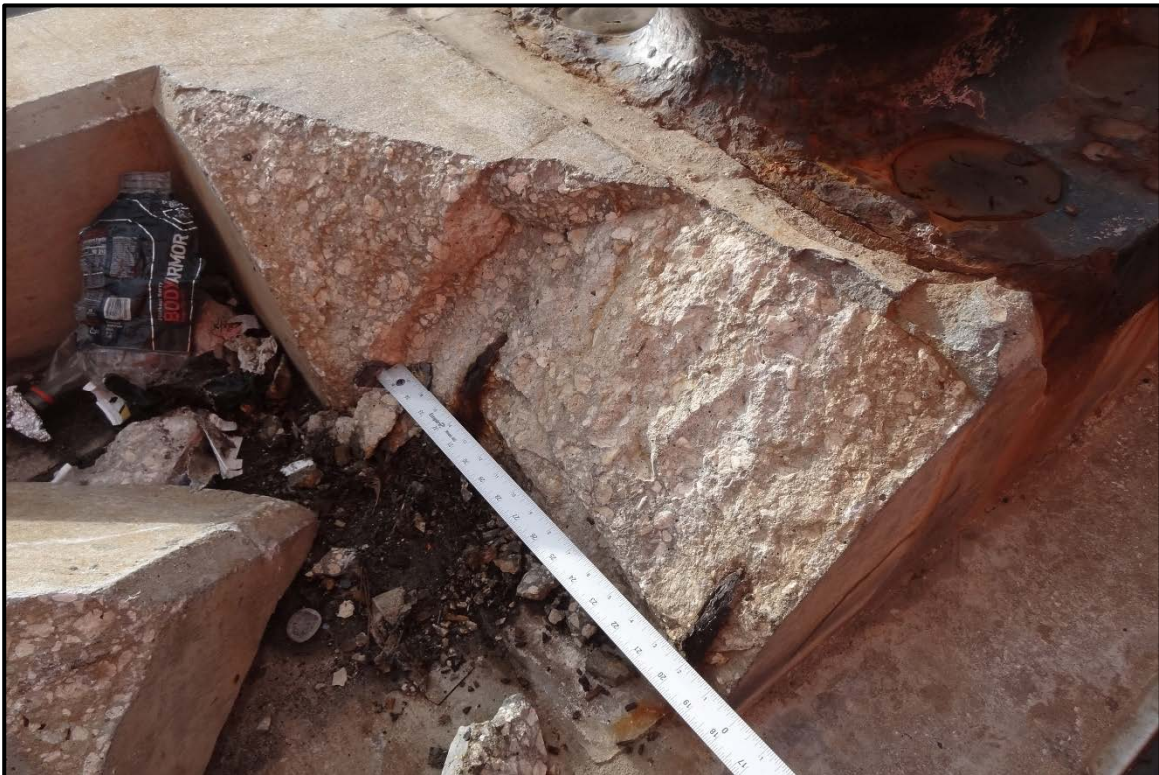
PHOTO 2-21 Mooring bollard foundation with spall exposing two reinforcing bars with severe corrosion.

- Repair of mooring bollard foundation spall at Station 24+60, with exposed steel reinforcing bars. Repair should include chipping to remove all loose and defective concrete and cleaning of the exposed reinforcing bars.

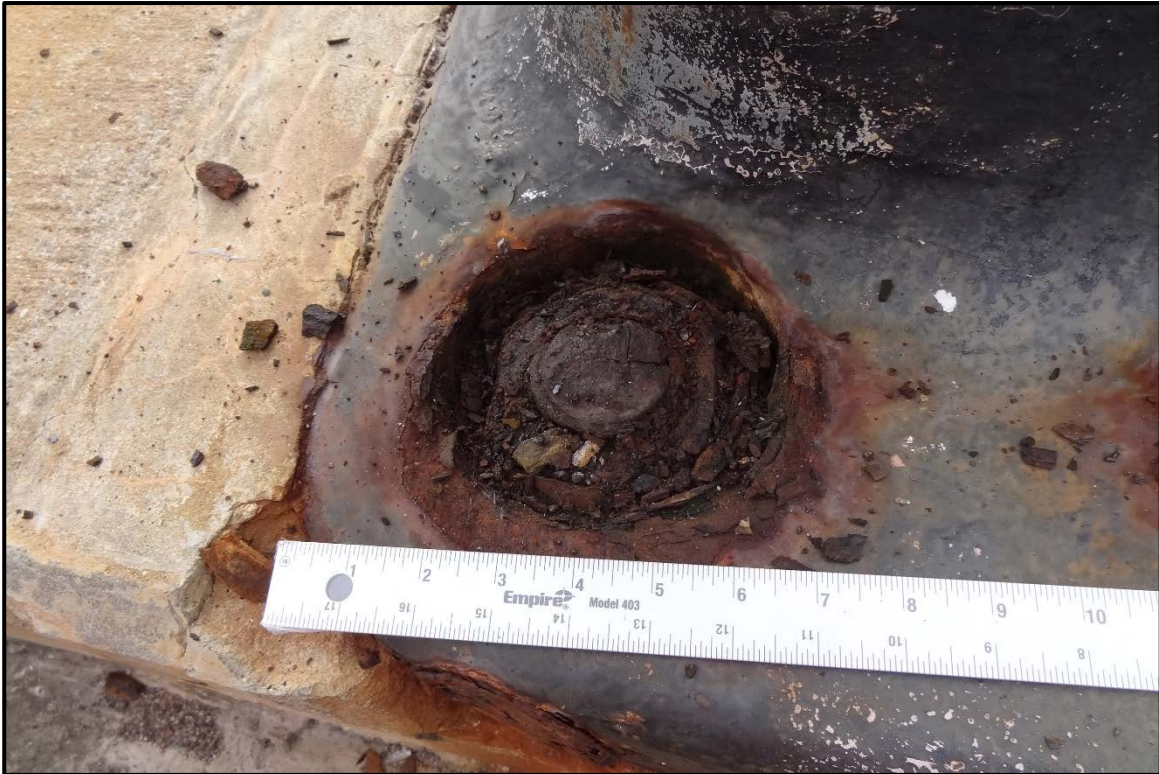
PHOTO 2-22 Exposed hardware on mooring bollard with major corrosion.

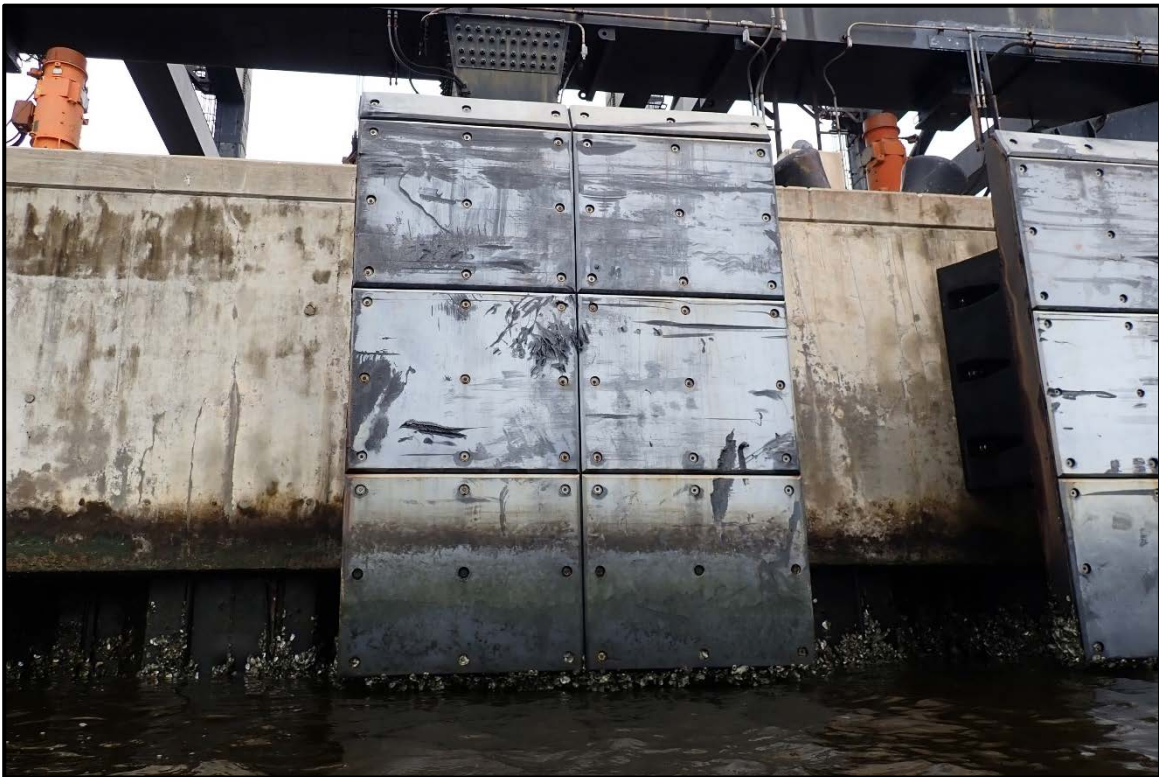
The fenders are in **Fair** condition. There is typically moderate cracking and gouging of the UHMW facing (Photo 2-23) and isolated panels are broken or missing (Photo 2-24). The panel backing frames typically display 15 to 20 percent coating loss with moderate corrosion, where uncoated (Photo 2-25). The rubber fender legs typically have minor to moderate defects. Isolated legs are beginning to crack and sag at the pile cap connections (Photo 2-26). At Station 7+80 the fender unit is missing (Photo 2-27) and the adjacent fender, at 7+90, has a large crack at its connection with the pile cap, and is beginning to rotate offshore. Additionally, the fender unit at Station 18+20 is missing an anchor bolt and is sagging. A summary of fender defects is presented below in Table 2-2.

PHOTO 2-23 Typical minor cracking and gouging on the fender UHMW panels.

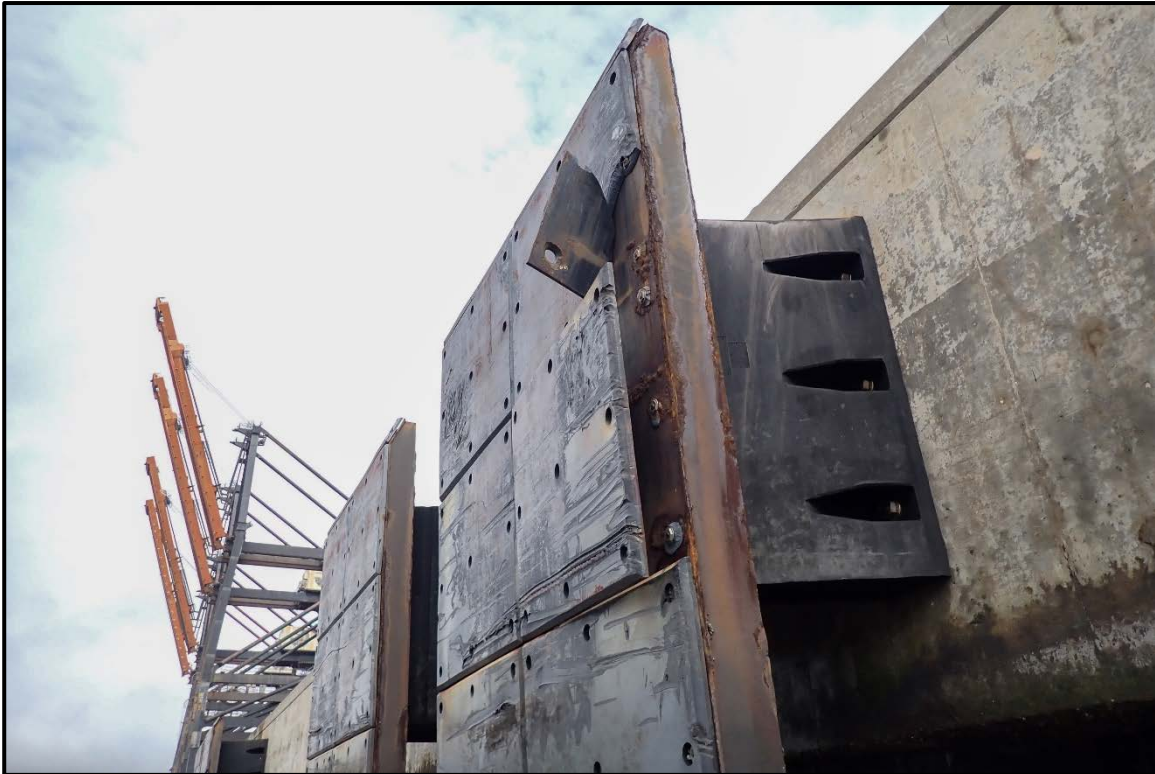
PHOTO 2-24 Loose and broken UHMW panels.

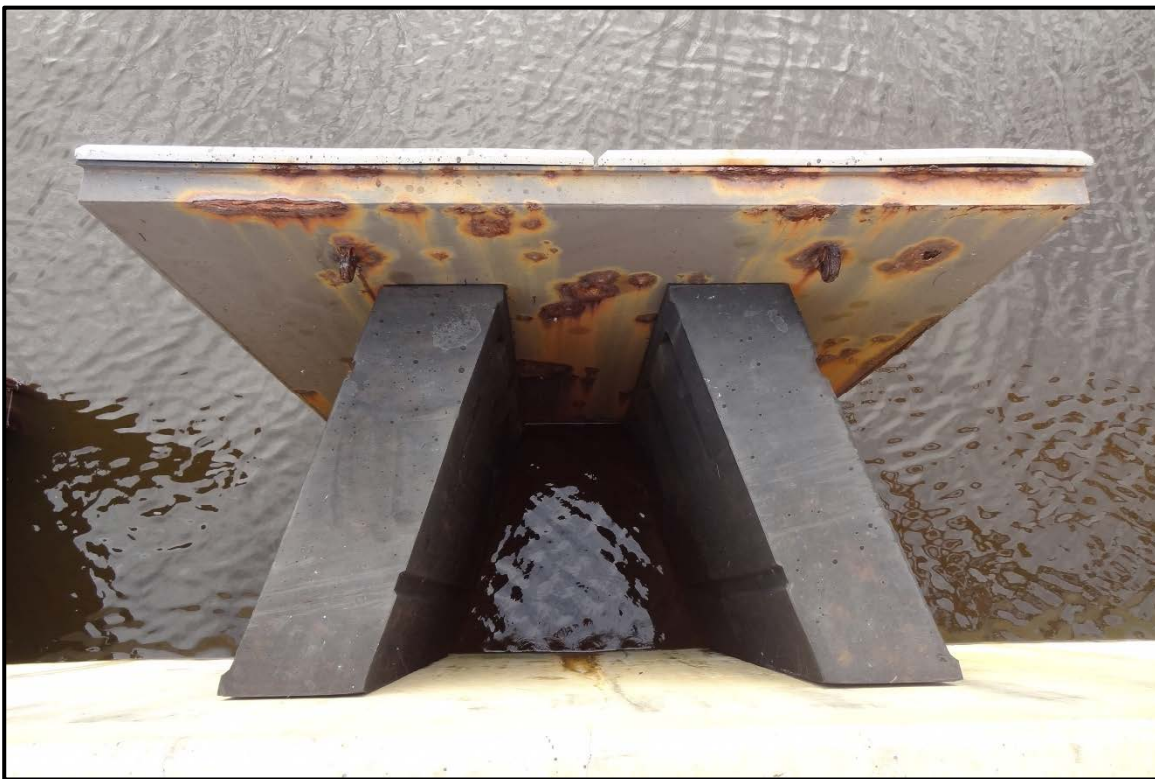
PHOTO 2-25 Typical coating loss with moderate corrosion and pitting on fender backing frame.

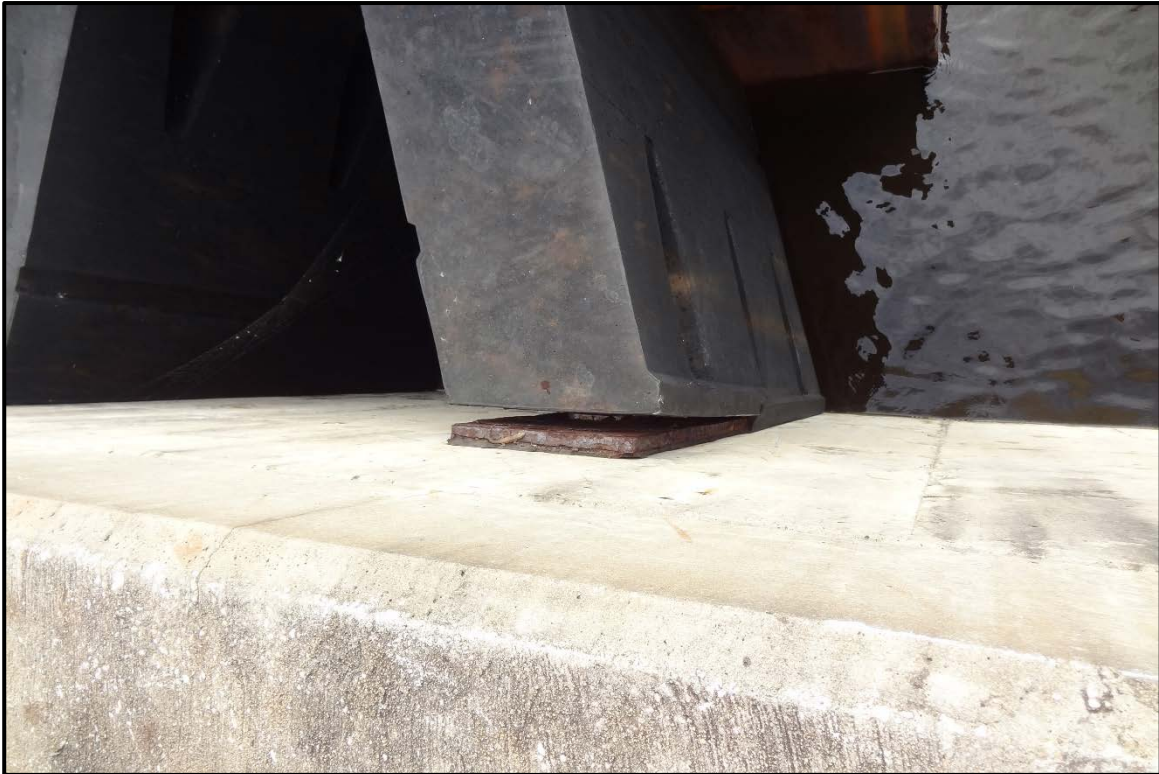
PHOTO 2-26 Rubber fender leg with crack and loose anchor bolt connection.

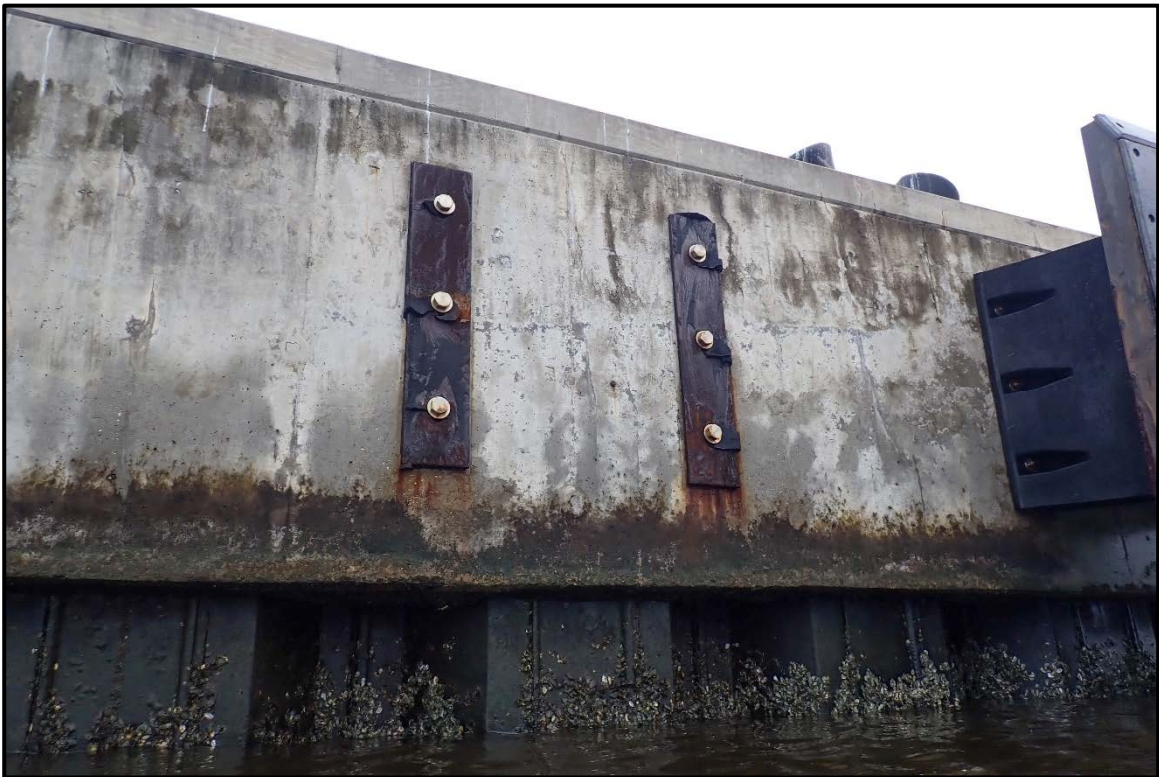
PHOTO 2-27 Missing fender unit at Station 7+80.

- Replacement of the missing fender unit at Station 7+80. At this location the connection hardware is in good condition, but the fender unit is missing. Repair should include procurement and replacement of a new fender unit in-kind, utilizing the existing hardware.
- Repair/Replacement of missing and broken UHMW facing panels on the fenders. There are a total of eight individual UHMW facing panels missing or broken on the fenders. Repair should include removing the broken panels and replacing them.
- Re-coating of the mooring bollards. The existing mooring bollards are in Satisfactory condition with relatively few defects. However, there is up to 30 percent coating loss with moderate corrosion and pitting at isolated bollards.

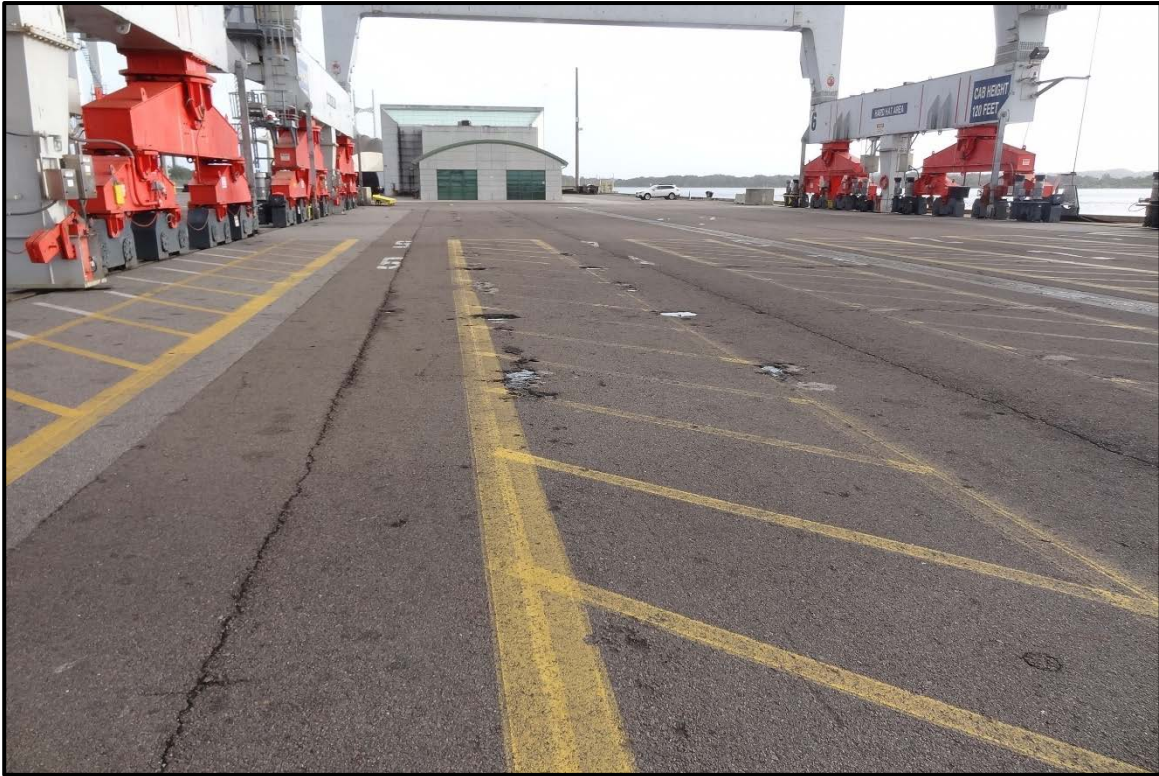
The asphalt pavement is in **Satisfactory** condition. There are minor potholes in the pavement, typical throughout the loading area under the cranes (Photo 2-28). There is an approximately 2.5-ft-wide concrete slab between the bulkhead capping beam and the waterside crane beam. It was noted that a 0.5 in. to 1.5 in. differential settlement was observed between the top of the capping beam and the concrete slab from Station 9+00 to Station 23+00 (Photo 2-29). The settlement of the slab is noted as being structurally independent of both the bulkhead and the cranes beams. No other settlements or evidence of movement were observed on the crane beams or crane rail during the inspection, indicating that the observed settlement is not due to any structural defects. No large depressions or evidence of fill loss or global movement of the fill material behind the bulkhead were observed during the inspection.

PHOTO 2-28 Typical potholes in pavement at Berth 17.

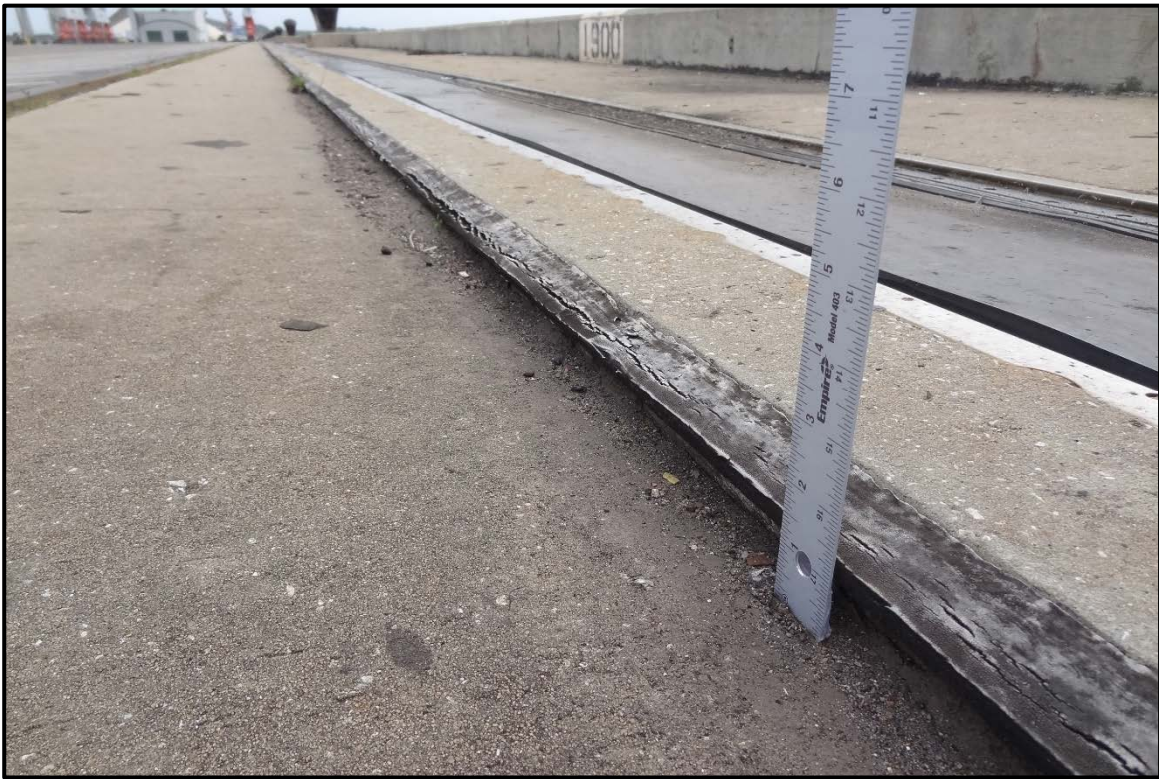
PHOTO 2-29 Differential settlement between capping beam and concrete slab located between the capping beam and crane rail beam.
